Storm Water Construction General Permit Inspection Report

RWQCB - Region 5S

Pine Grove Bluffs

2/23/2009

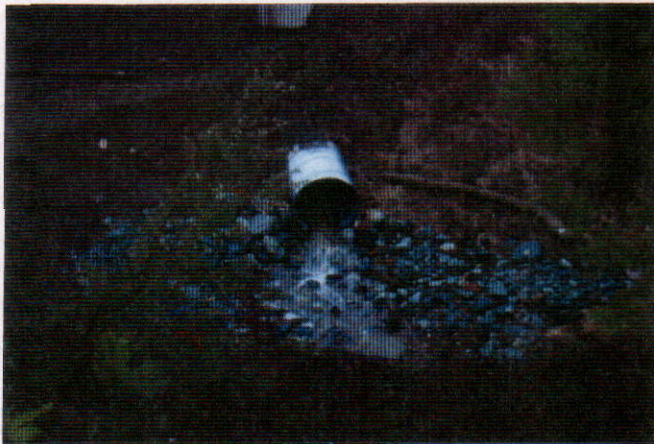
During the site inspection staff observed significant storm water management problems on the construction site. The inspection was conducted just after a significant rain event that had occurred the previous day and throughout the night. Light rain was falling during the site inspection. The entire site was again walked and staff observed no significant improvement to the BMPs since the site inspection the previous day. Staff again observed a turbid storm water discharge from both outfall areas. The western outfall location was sampled and flow was measured in the discharge channel. Using a field turbidity meter the turbidity was 384 NTUs at the outfall location. Jackson Creek was also sampled upstream of the construction site using a field turbidity meter and the turbidity level was 30 NTUs (see inspection photographs).

Figure 1: Turbid storm water discharging from the construction site

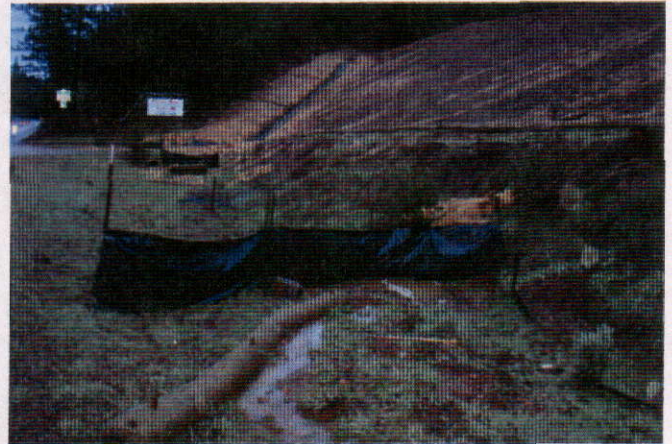
Figure 2: View of the western discharge location

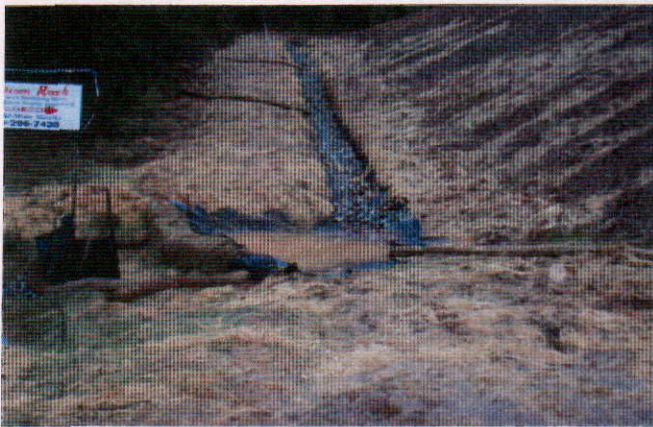
Figure 3: Another view of the western discharge location

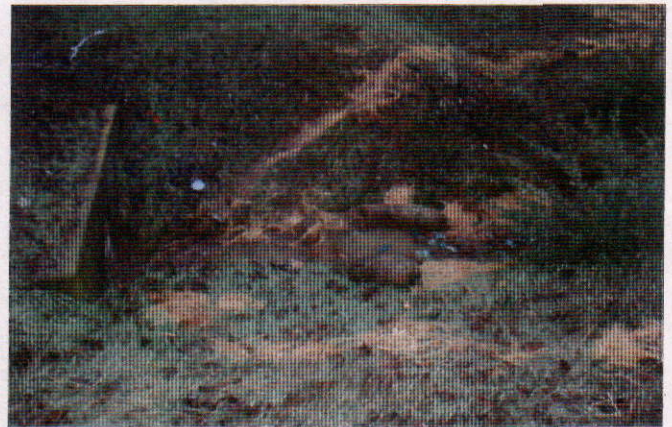
Figure 4: Turbid storm water flowing into the western culvert which discharges into Jackson Creek

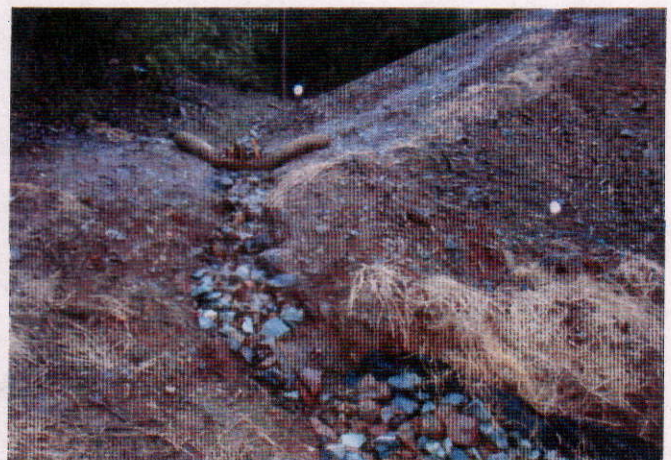
Figure 6: Area above the western discharge location where staff observed no effective storm water management BMPs

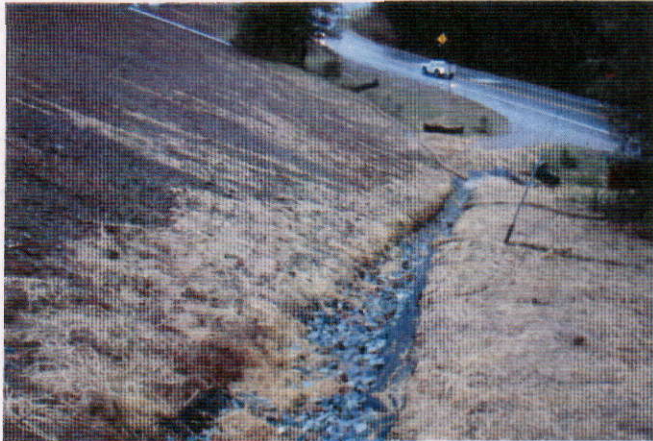
Figure 7: Area directly below the area shown in Figure 6

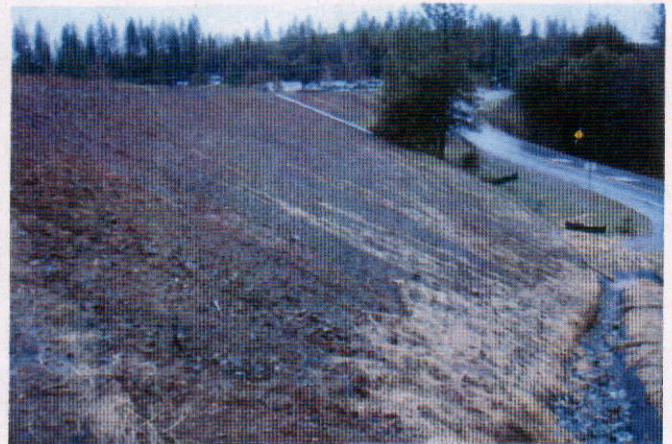
Figure 8: Same area Note: the general lack of BMPs on the slope

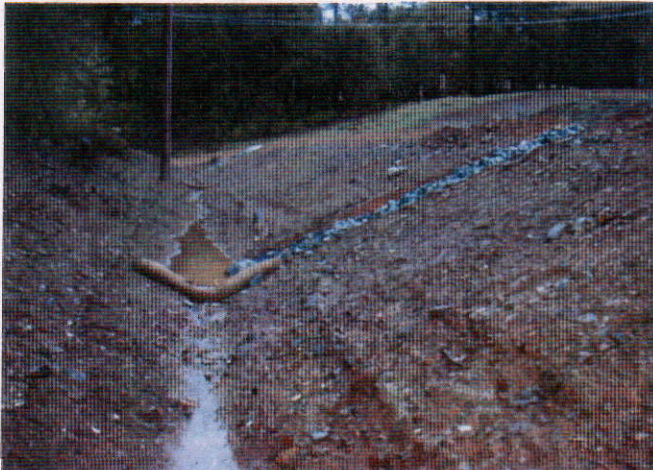
Figure 9: Area above the discharge location in Figure 8 Note: the lack of erosion control BMPs

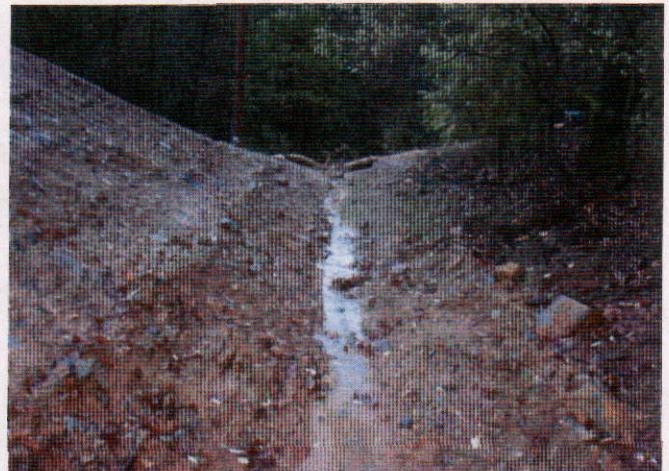
Figure 10: View of the same area

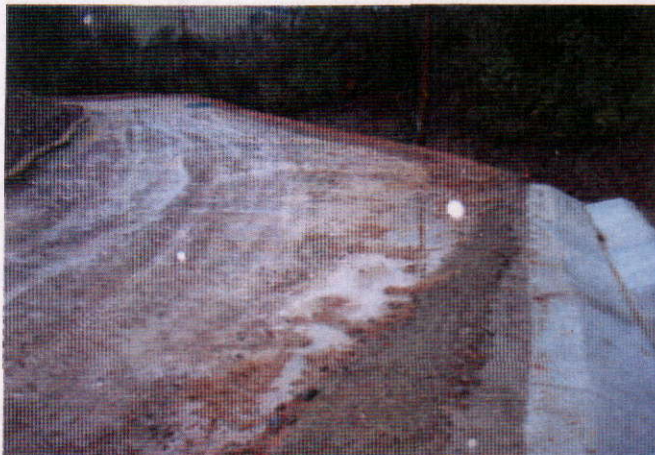
Figure 11: General lack of BMPs above the area in Figure 9

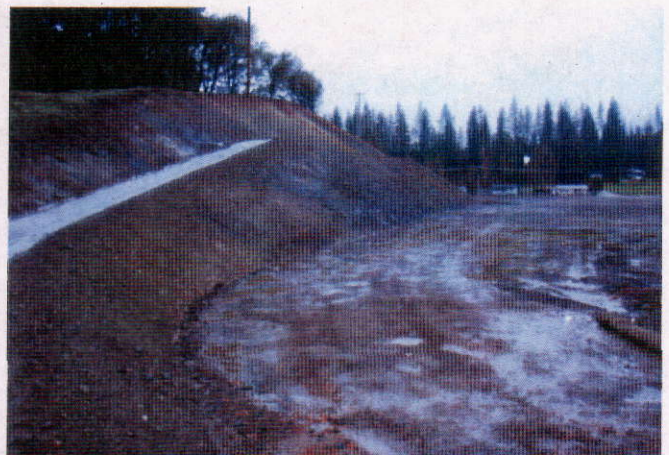
Figure 12: Lack of an effective combination of erosion and sediment control BMPs

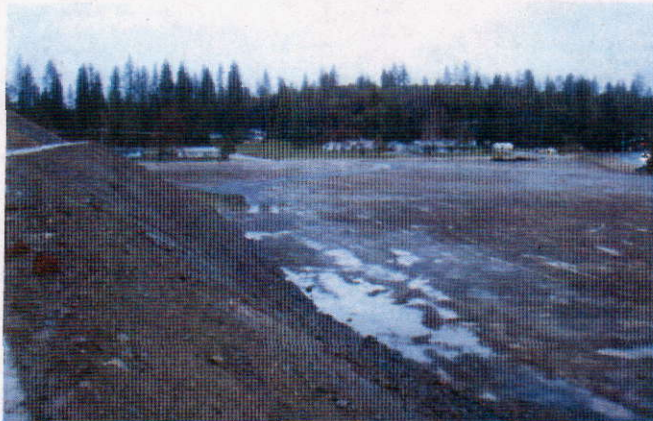
Figure 13: Lack of an effective combination of erosion and sediment control BMPs

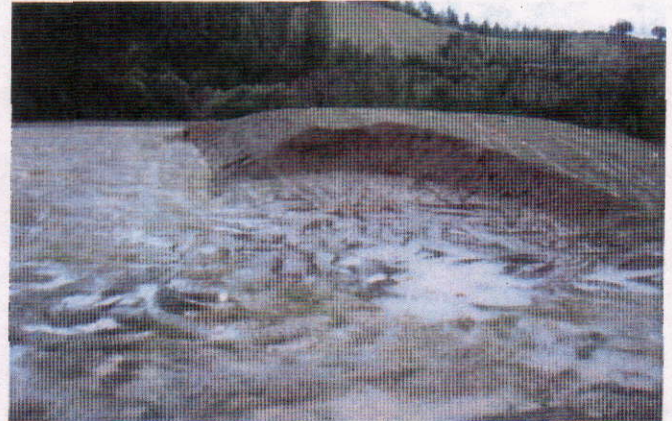
Figure 14: Poorly stabilized stockpile

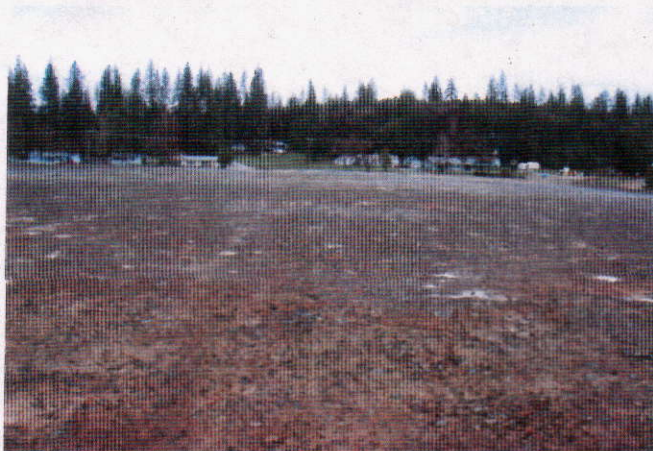
Figure 15: Lack of an effective combination of erosion and sediment control BMPs

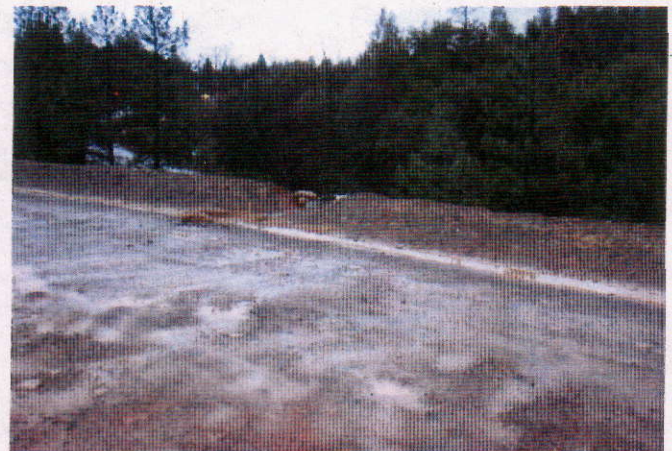
Figure 16: Lack of an effective combination of erosion and sediment control BMPs prior to one of the discharge locations

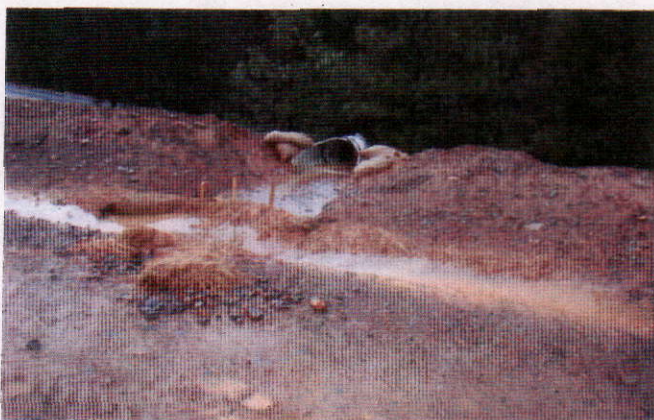
Figure 17: Fiber rolls installed prior to turbid stormwater discharge into the down drain

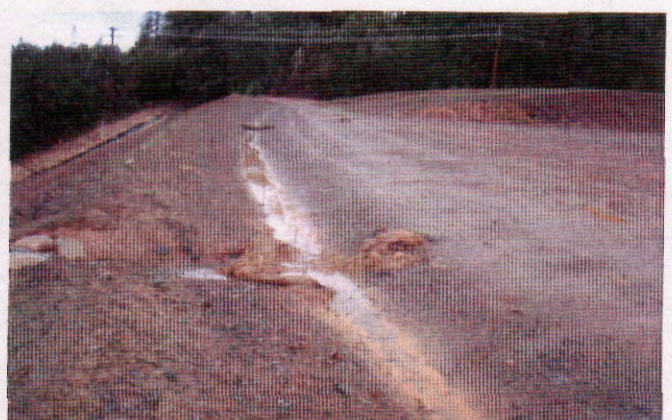
Figure 18: Another view of the fiber rolls installed prior to discharge into the down drain

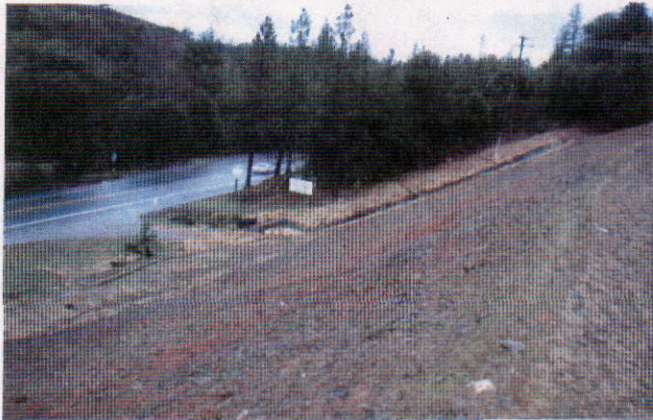
Figure 19: Poorly protected slope

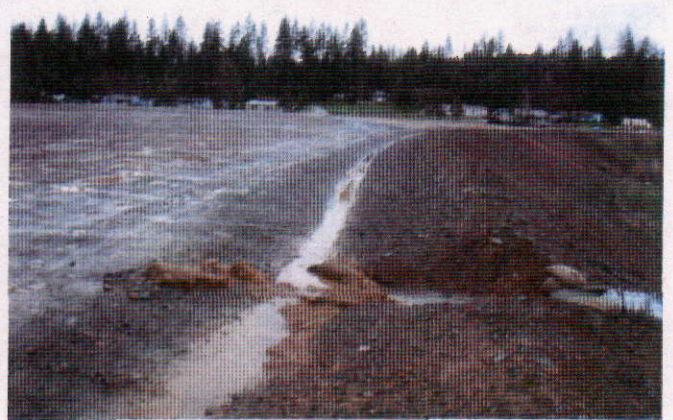
Figure 20: Lack of an effective combination of erosion and sediment control BMPs Note: the discharge into the down drain and the lack of effective BMPs prior to the down drain

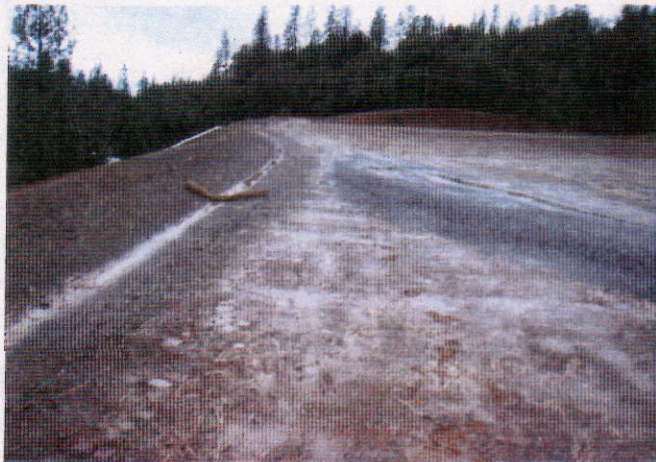
Figure 21: Lack of an effective combination of erosion and sediment control BMPs

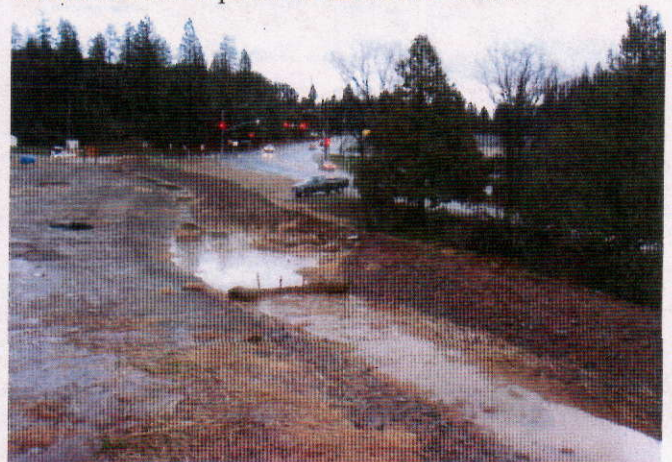
Figure 22: Turbid storm water ponded onsite

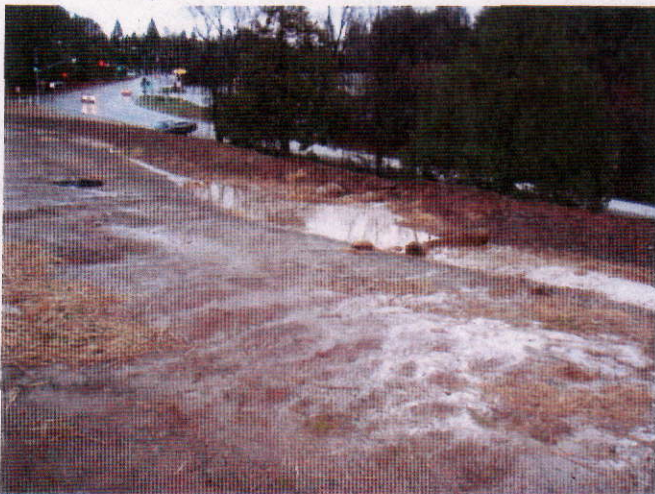
Figure 23: Another view of the same area Note: the general lack of erosion control BMPs

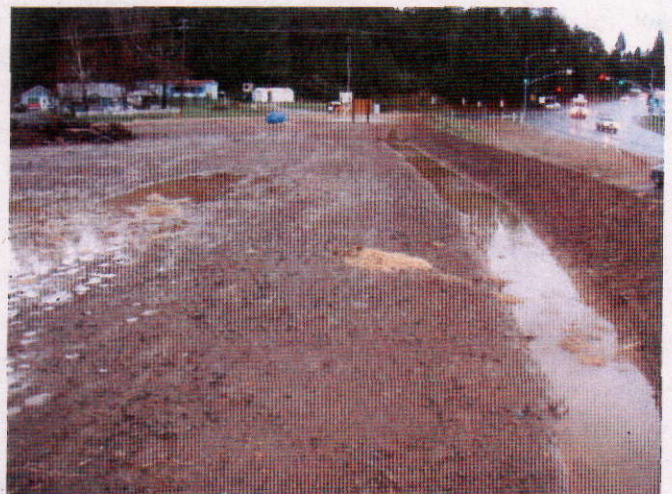
Figure 24: Lack of an effective combination of erosion and sediment control BMPs

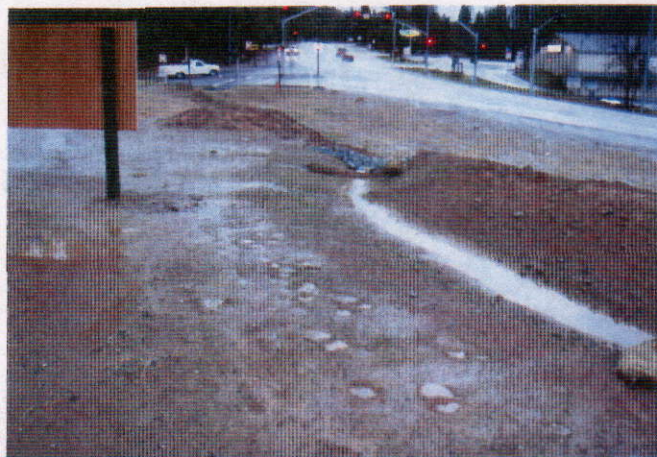
Figure 25: Lack of an effective combination of erosion and sediment control BMPs Note: the only BMP installed is a fiber roll

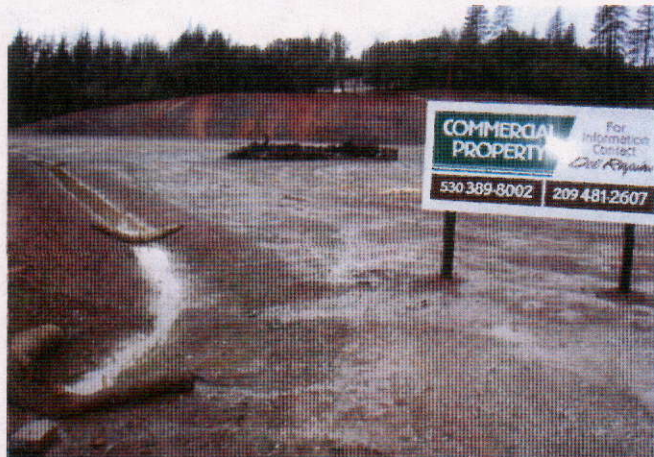
Figure 26: Another view of the same area Note: the lack of erosion control BMPs

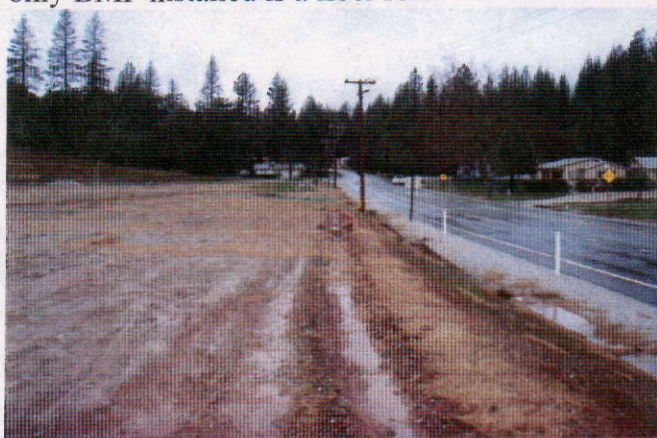
Figure 27: Light application of straw mulch along Ridge Road

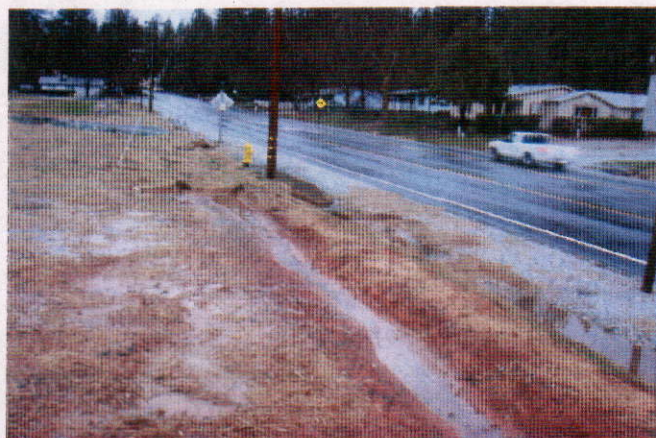
Figure 28: Sediment laden storm water flowing down to the drain inlet adjacent to Ridge Road

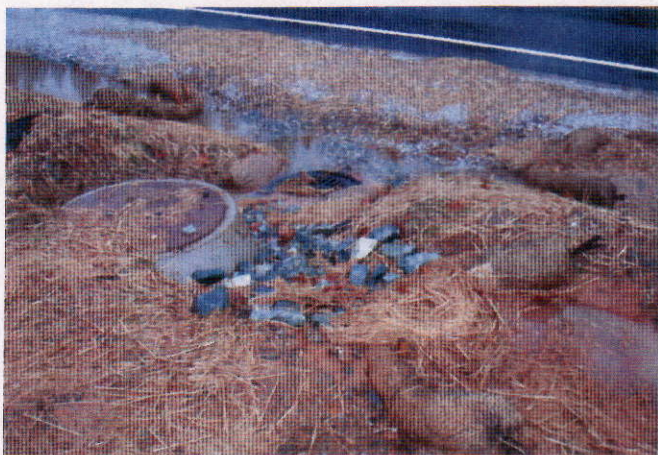
Figure 29: Turbid storm water flowing into the drain inlet along Ridge Road

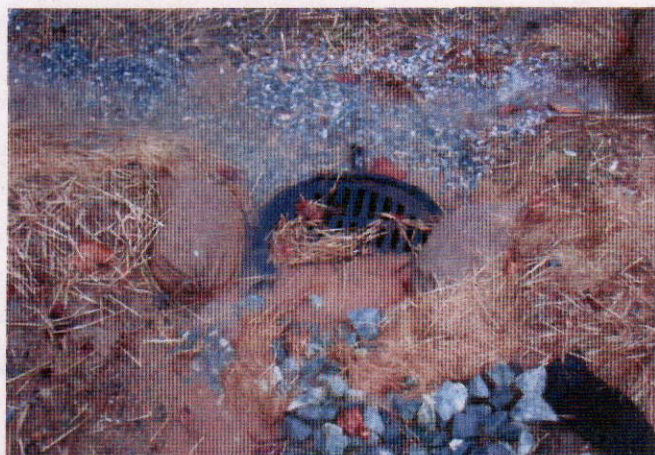
Figure 30: Another view of the drain inlet along Ridge Road

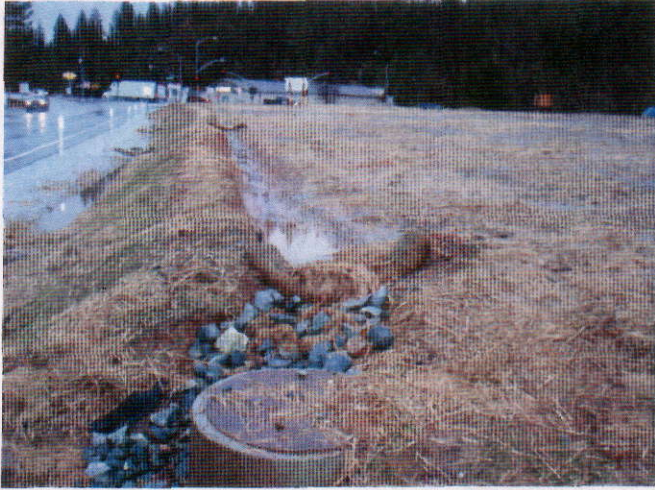
Figure 31: Another view of the area just above the drain inlet on Ridge Road

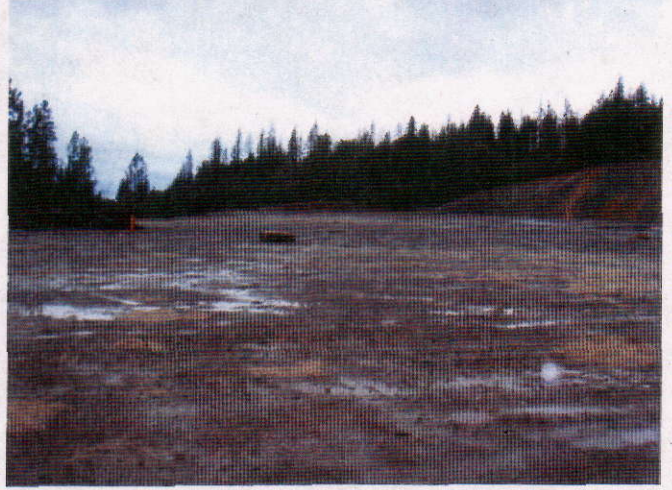
Figure 32: Lack of an effective combination of erosion and sediment control BMPs
